**PRELIMINARY ASSESSMENT/  
VISUAL SITE INSPECTION**

**CLYDE PAINT AND SUPPLY CO.  
CLYDE, OHIO  
OHD 005 048 459**

**FINAL REPORT**

Work Assignment No.	:	C05087
EPA Region	:	5
Site No.	:	OHD 005 048 459
Date Prepared	:	October 28, 1992
Contract No.	:	68-W9-0006
PRC No.	:	009-C05087OH81
Prepared by	:	PRC Environmental Management, Inc. (Deb Harrity)
Contractor Project Manager	:	Shin Ahn
Telephone No.	:	(312) 856-8700
EPA Work Assignment Manager	:	Kevin Pierard
Telephone No.	:	(312) 886-4448

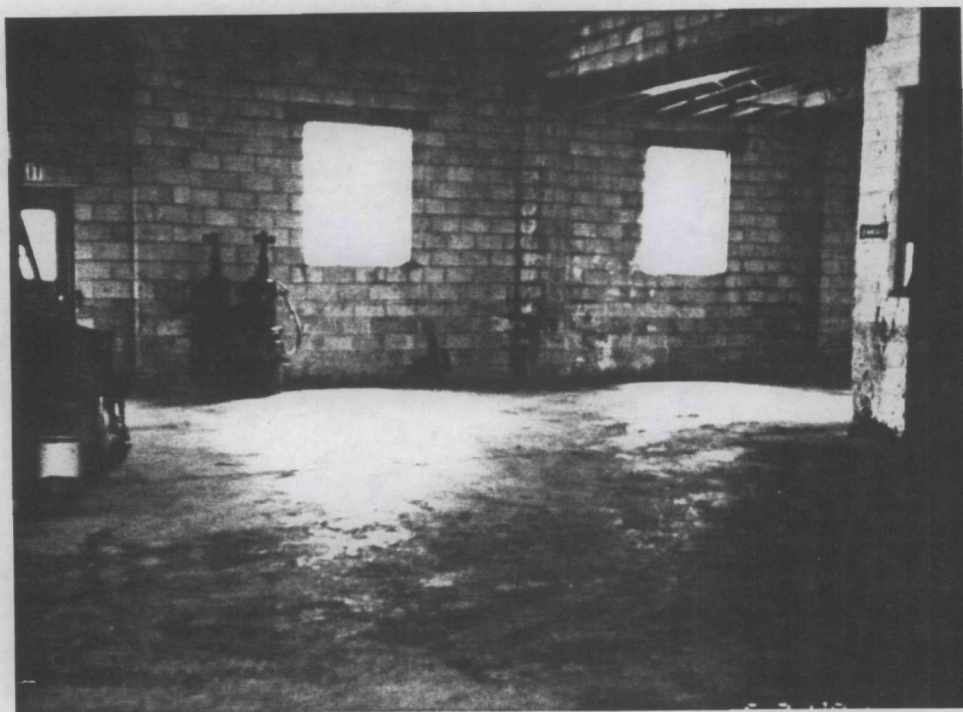
Location: SWMU 1  
 Date: 05/21/91

**Observations:** At the time of the inspection, PRC observed that the CSA no longer stored any containers of waste, and PRC observed no evidence of releases.

Photograph No. 1  
 Orientation: Southeast  
 Description: Closed CSA on the first floor of the recycling building.

**Recommendations:**              This unit has been decontaminated and certified closed by OEPA. PRC recommends no further action for this unit.

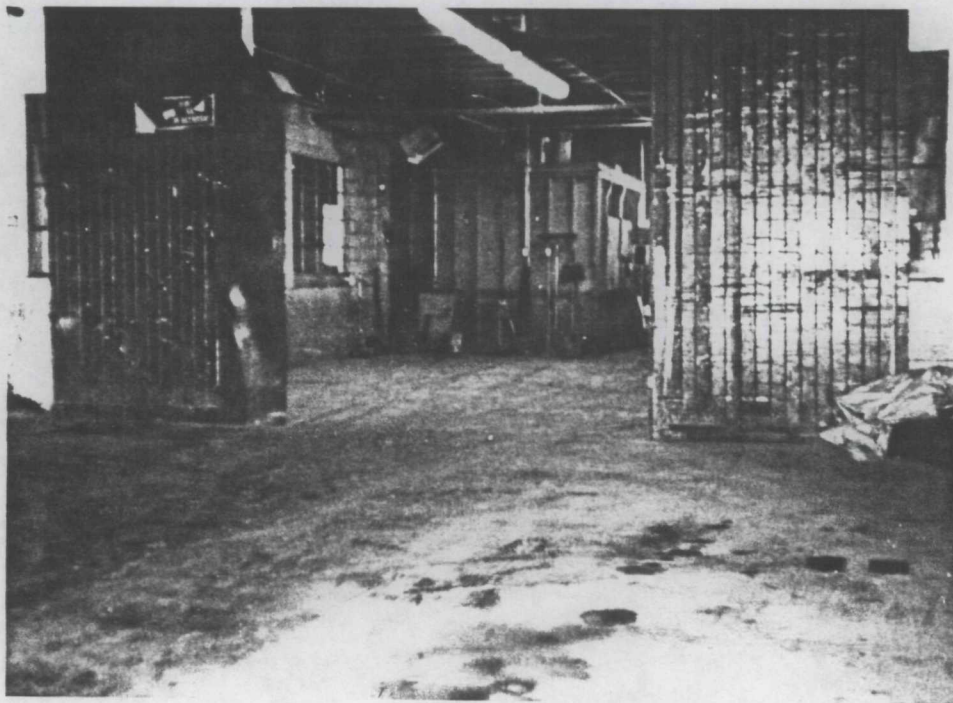
Location: SWMU 1  
 Date: 05/21/91

Photograph No. 2  
 Orientation: Southeast  
 Description: Closed CSA on first floor of recycling building.

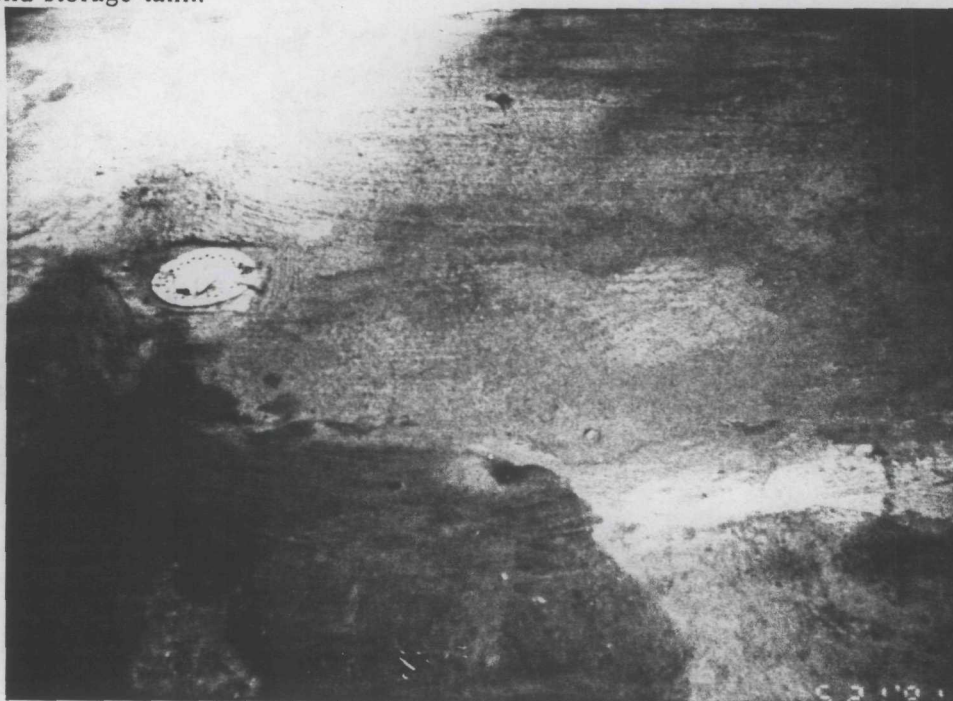
Photograph No. 6

hazardous waste. This unit was constructed of carbon steel and had a capacity of 3,000 gallons (Photo 6).

Observations: At the time of the inspection, PRC observed the area where the unit was located. The floor was filled with concrete, and PRC observed no evidence of a release.

Recommendations: This unit has been decontaminated and removed. PRC recommends no further action for this unit.

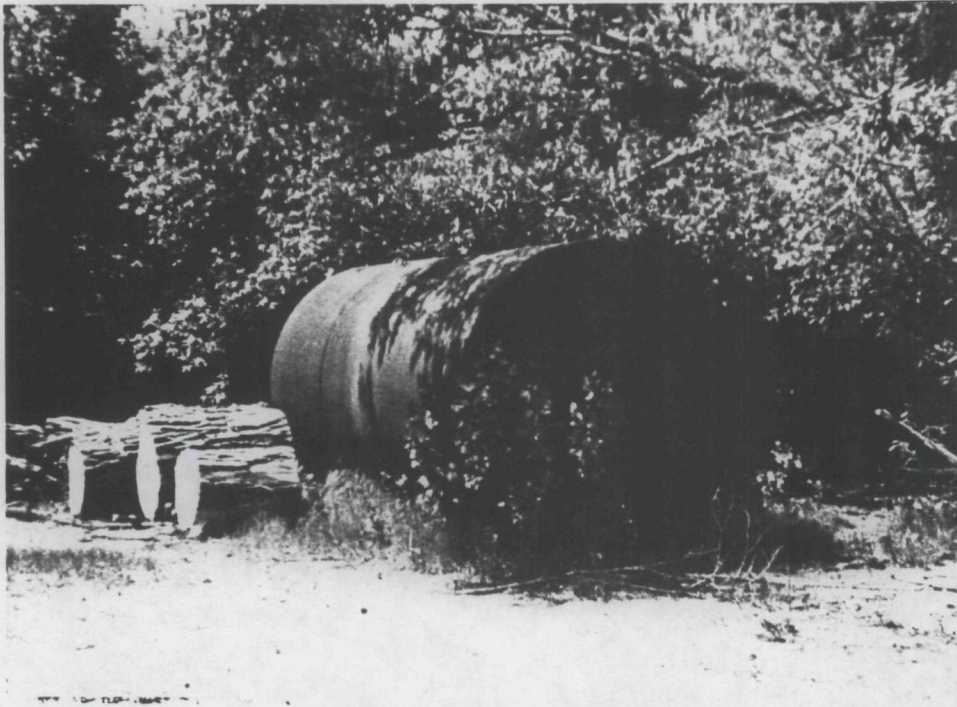
Photograph No. 9

**Unit Description:** This unit was located outdoors on the west side of the building, adjacent to the facility driveway. According to Lynn Naggy, the UST contained product xylene. However, according to the facility closure plan and OEPA, this unit may have contained hazardous waste. This unit was constructed of carbon steel and had a capacity of 6,000 gallons (Photos 9, 11 and 12).

**Observations:** At the time of the inspection, PRC observed the 6,000-gallon empty tank located at the south end of the property. PRC observed no signs of releases in the area where the unit was located. The area where this unit was located was well vegetated.

Recommendations: This unit has been decontaminated and removed. PRC recommends no further action for this unit.

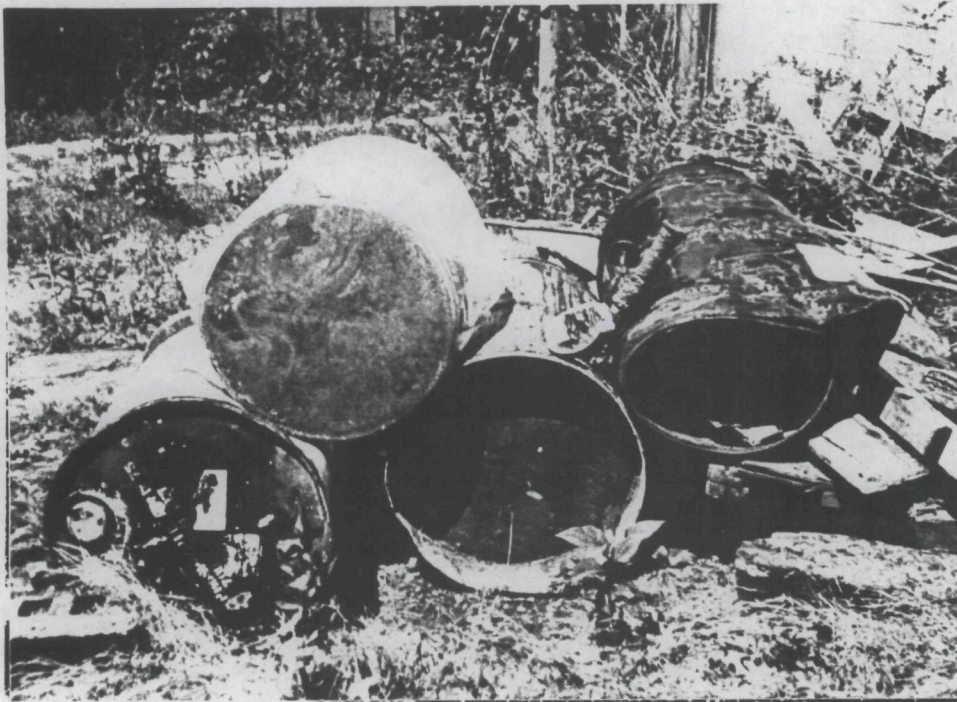
Photograph No. 10

PRC identified one 55-gallon drum of unknown contents outside the southern end of the recycling building that used to belong to the CPS facility. PRC observed the 55-gallon drum lying on the ground with a valve on the bottom. The drum was covered with dried paint. PRC considers this an AOC because according to facility files, all of the containerized waste was removed in 1985, and there is potential for release from the container. There was no evidence of release from this container at the time of the inspection.

This drum poses a small threat of release. The drum has no release controls, and PRC observed evidence of dried paint on the exterior of the drum. In addition, the drum contents are unknown. CPS should have the contents of the drum analyzed, and the drum should be removed from the site.
